**REPORT OF OPERATION SILENT ANZAC  
MARITIME ARCHAEOLOGICAL ASSESSMENT OF HMAS  
AE2**

Name	Position
<b>Prepared By:</b>	Tim Smith	Maritime Archaeologist
<b>Approved By:</b>	Terence Roach	Director of Operations
<b>Authorised By:</b>	Peter Briggs	Chairman AE2CF

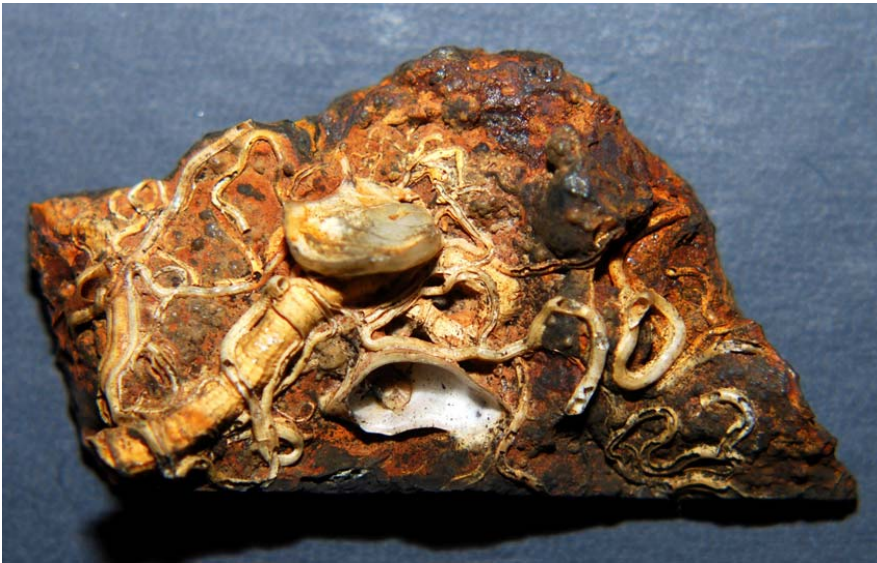
Figure 6: Concretion sample from AE2 showing scrupled worm casts and small oyster shells

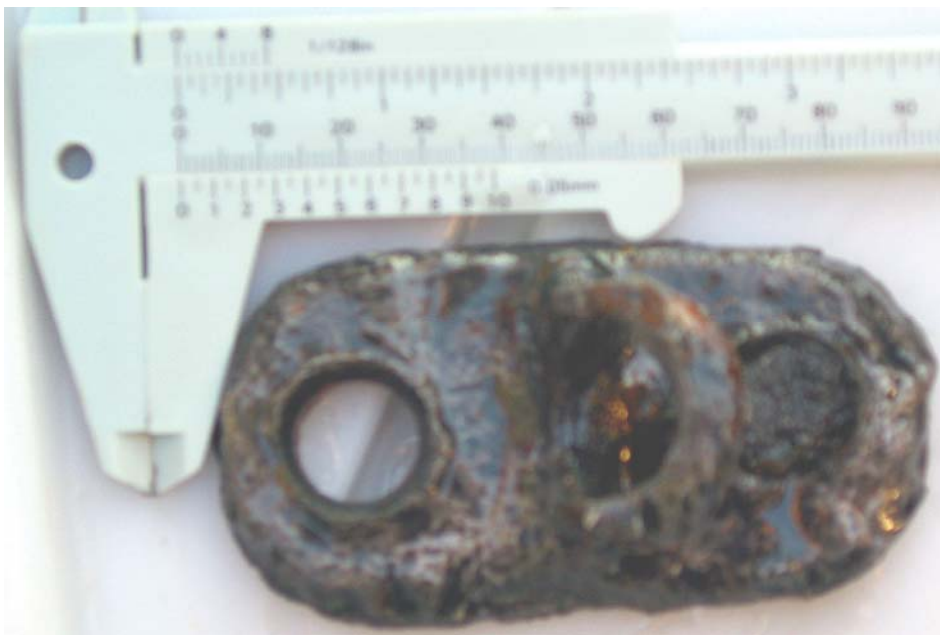
During the movement of the shot line anchor across the submarine a ring bolt bracket was dislodged from the vessel and recovered by divers who handed the object to the care of Turkish authorities once it had received emergency first aid treatment of being soaked in an alkaline carbonate solution. Examination of the bolt showed that it suffered normal wrought iron degradation in that the metal was torn rather than being fractured like a cast iron fitting would have been – see Figure 7. There was very active corrosion around the tear line on the bracket and within minutes of recovery the normal weeping patterns of a clear liquid transforming into a red-brown akaganeite crusty growths. The amount of residual solid metal in several parts of the bracket was very small.

Figure 7: Details of the ring and sheared off bolt fitting from the side of the submarine

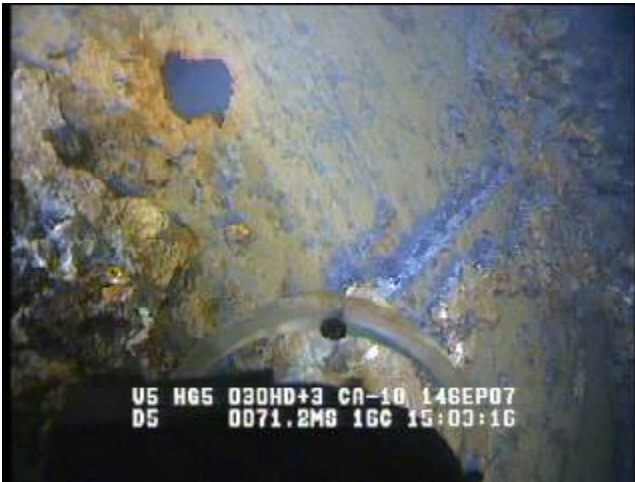
The fabric of the pressure hull and saddle tanks appears to be substantially intact. There is no evidence of gross damage or significant discontinuities due to corrosion in either. Due to an unplanned impact of a concrete block on one area of the hull, on the port side in the vicinity of frame 41, the concretion was removed from a portion of the ballast tank. This revealed that there are localized, small (in the vicinity 25-50 mm diameter) corrosion holes. An example is shown in Figure 4.

Figure 4. Showing a hole through to the portside saddle tank, in vicinity of Frame 41. Note also the overlay of the plating, and rivets.

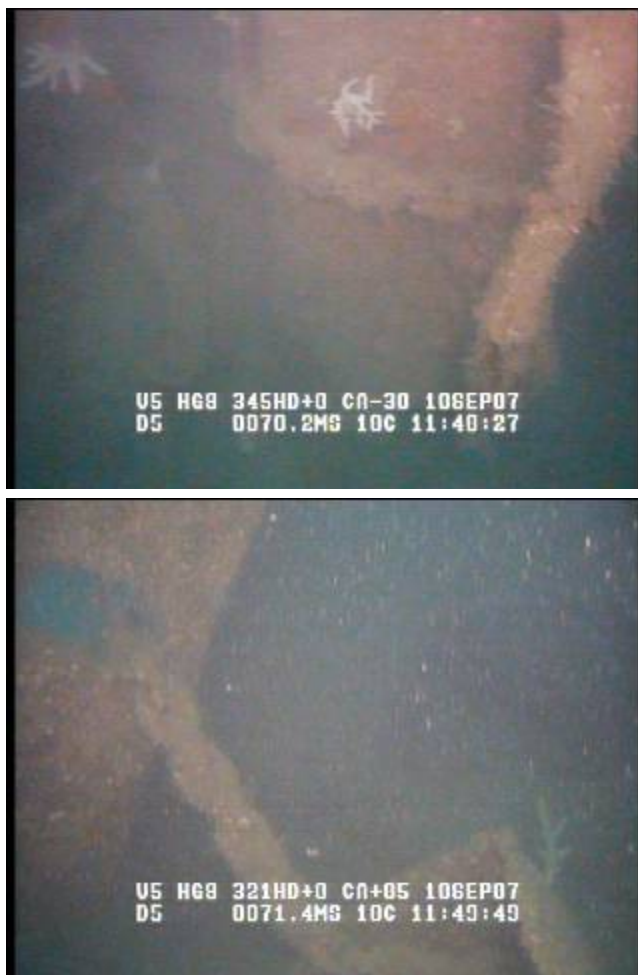
In contrast to the relatively good condition of the main hull and saddle tanks, the casing has sustained significant damage, apparently as a result of either fishing activity or an anchor dragging across the site. This, damage, accompanied by the loss of sections of the casing as a result of corrosion of its relatively light plating, has resulted in the profile of the submarine being largely lost for a substantial proportion of its length. At some time between the initial, 1998 dives on the vessel and 2007, the portside towing pennant has been fouled by either fishing equipment or an anchor and dragged across to the starboard side of the hull. This resulted in a substantial section of the casing being broken away and deposited on the starboard side of the vessel (approximately between frame 72 and 83), and the fairwater at the bow being split and 'peeled back', with destruction of approximately the first five metres of the casing (estimated to be from frame 93 forward).

Figure 5. Shows how the portside towing pennant has 'peeled back' the plating of the casing at the bow.

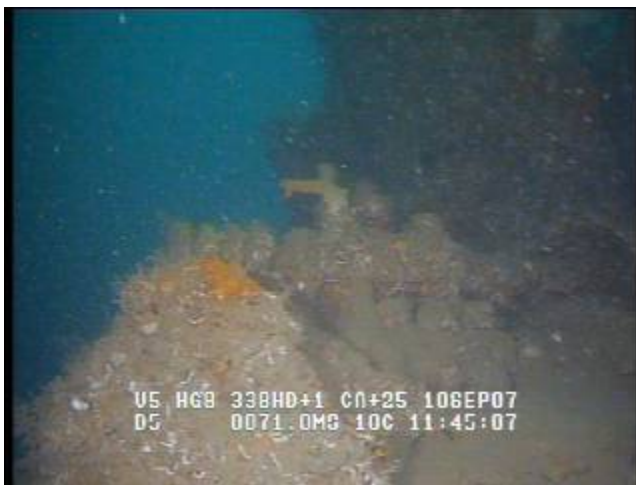
Figure 6. At lower left is the bow cap of the forward torpedo tube, and its associated opening mechanism. The worm gear is visible as is the support frame and bearing and shaft. The quadrant gear, not visible in this image, is intact and correctly engaged with the worm gear.

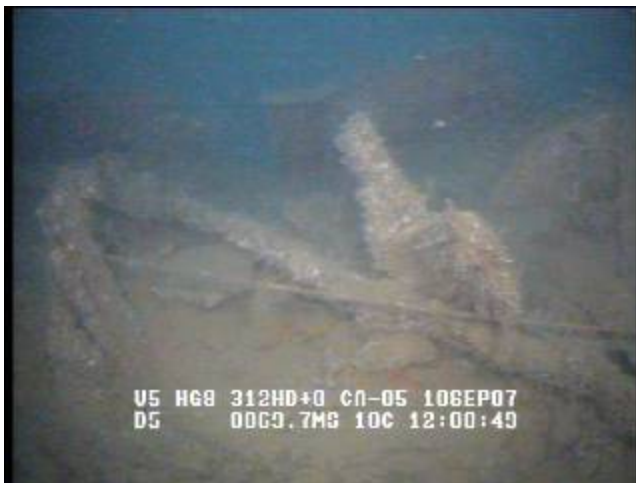
The following image shows the towing pennant lying across the top of the hull in the vicinity of frame 75. The pennant has actually parted, but only after causing this significant amount of destruction. Interestingly, it was the fact that biological concretion had bonded the pennant to the hull that enabled the equipment which fouled the pennant to gain such destructive purchase.

Figure 7. Showing the portside towing pennant lying across the hull. Left of image is forward.

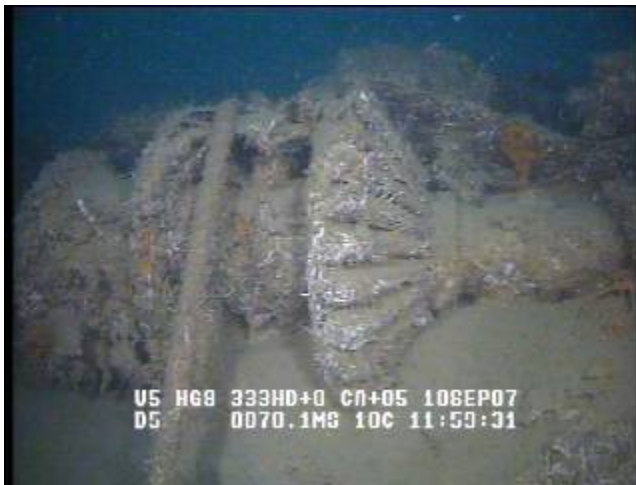
Figure 8. Anchor Winch, looking from the port side. The rope lying over is fishing debris.

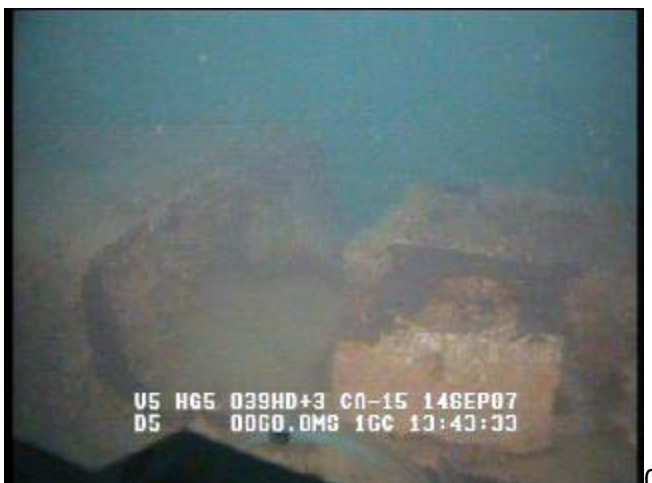
Moving aft from the break in the casing in vicinity of frame 72 the casing is substantially complete until the vicinity of the aft torpedo loading derrick at frame 42. In this vicinity the casing has been substantially compromised between frames 40-43, as can be seen in Figure 10

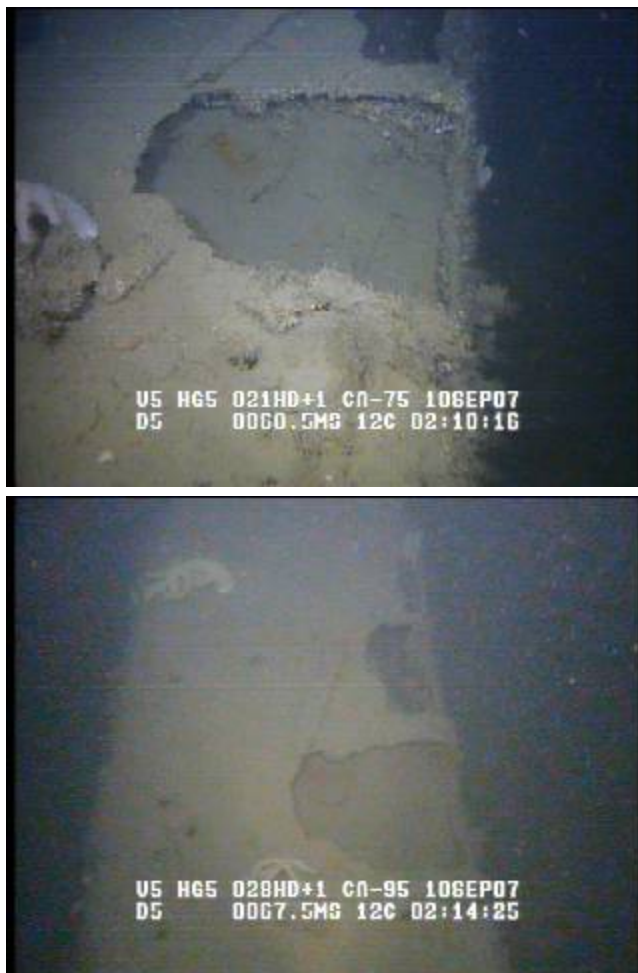
There is one final area of substantial damage to the casing, in the vicinity of the main exhaust muffler (around frame 30). There is a semi-circular opening, plus two smaller holes, with an underlying structure evident under the aft-most holes. While the holes could be a result of strikes from fishing equipment, in this case a more likely cause is that this simply represents localized higher levels of corrosion, resulting from the heat-cycling effects of the underlying exhaust system, on both steel and paints. This is consistent with observations by Ian MacLeod (Personal Communication) of accelerated corrosion, in the vicinity of their exhaust stacks, on the former HMAS Swan and Perth [now sunk as dive wrecks off the West Australian coast] as illustrated in Figure 11 below.

Figure 11. Substantial corrosion holes in the aft casing in the vicinity of the exhaust system.

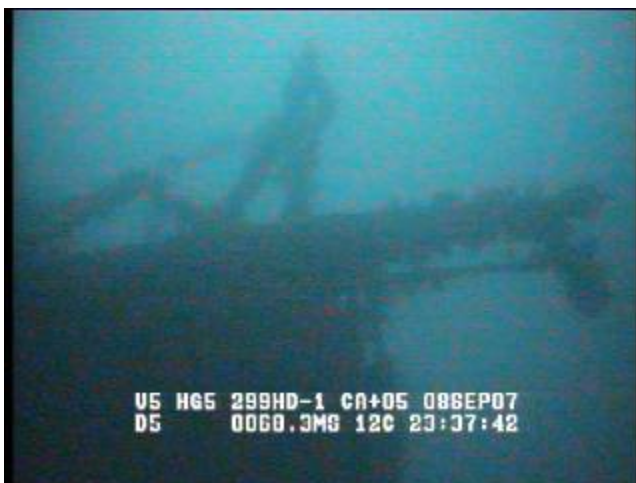
7.3 The aft end of the fin showed significant loss of plating on its vertical faces. Approximately 1.2 metres of the aft plating has been removed. Continued corrosion has resulted in the removal or collapse of the aft portion of plating, reducing the visual scale of the original fin surface area. It is possible that further net hook-ups have occurred here since 1998, speeding up the deterioration and deformation process.

Figure 17. A view looking up at the aft end of the fin, showing that the rear portion of the structure has completely corroded away.

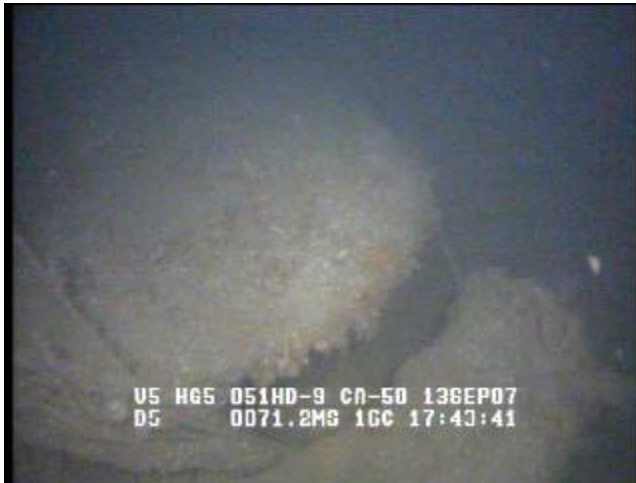
Figure 18. Forward Port hydroplane and plane guard. Note fishing nets caught between the two.

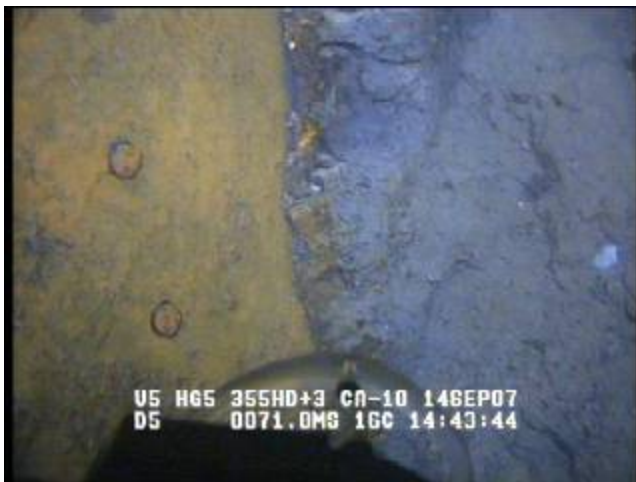
Figure 30. ‘Started’ rivets on portside saddle tank.

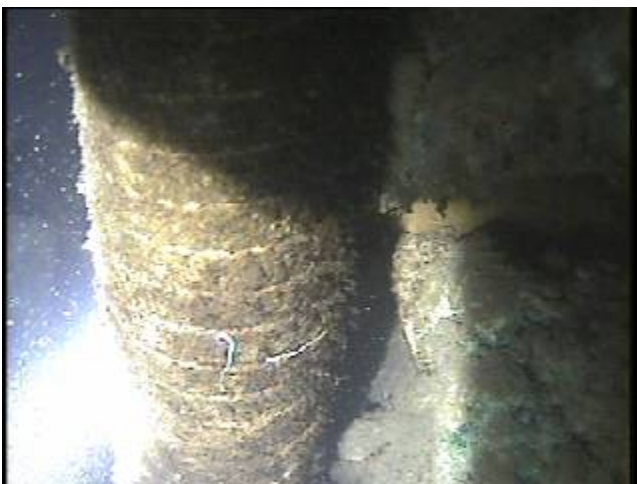
Figure 38. A lagged pipe on the starboard side of the conning tower, shows lagging – presumably asbestos - in excellent state of preservation.
