**REPORT OF OPERATION SILENT ANZAC  
MARITIME ARCHAEOLOGICAL ASSESSMENT OF HMAS  
AE2**

Name	Position
<b>Prepared By:</b>	Tim Smith	Maritime Archaeologist
<b>Approved By:</b>	Terence Roach	Director of Operations
<b>Authorised By:</b>	Peter Briggs	Chairman AE2CF

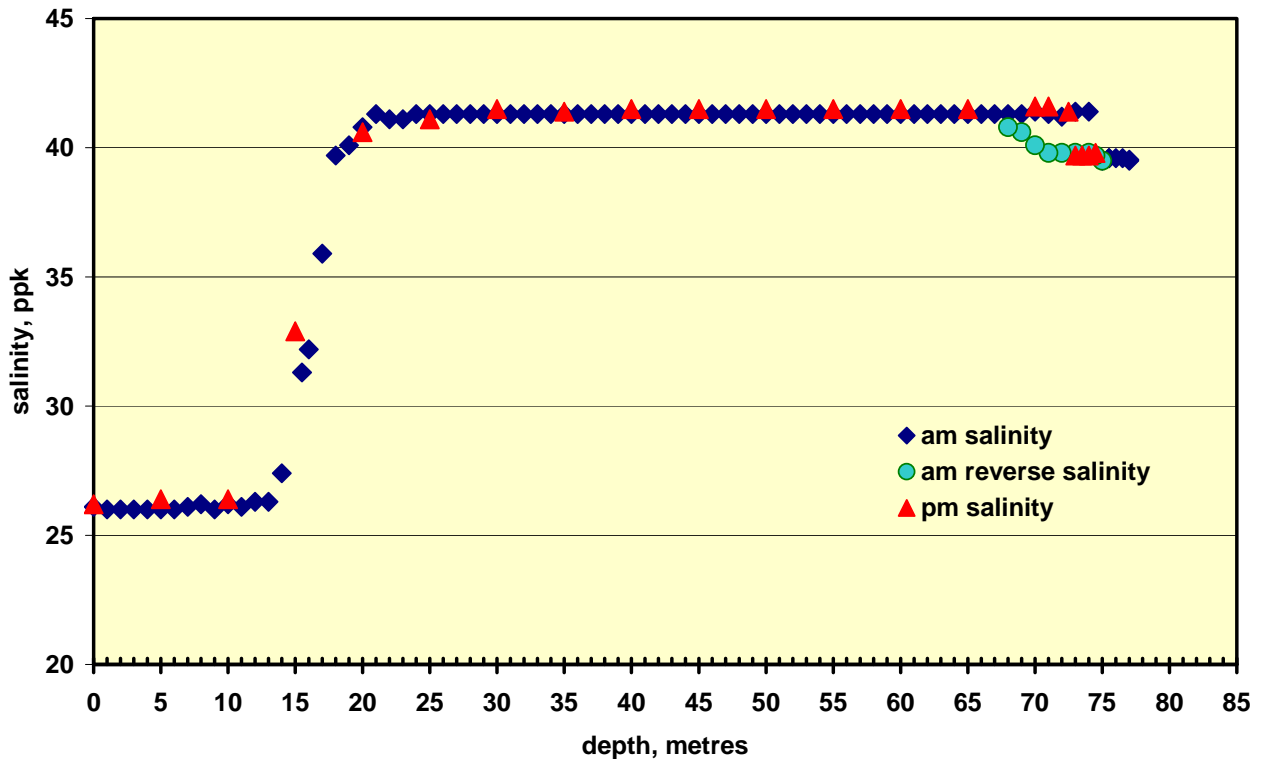
Figure 2: Salinity profile on the AE2 site, Sea of Marmara, September 2007

Since a 2kg lead weight had been attached to the sensing heads for the dissolved oxygen and salinity probes, to keep the sensors vertical in the water column, the salinity values recorded during recovery of the long cable leads may reflect the chloride activity in the upper sediment layer. The mean salinity of the surface waters was  $26.1 \pm 0.1$  ‰ or parts per thousand and this reflects values associated with the influx of waters from Black Sea, which has a mean salinity of approximately 18‰, into the Sea of Marmara. The increased salinity of the upper water compared with the Black Sea is due to the low run-off of streams feeding the Marmara and due to the relatively high evaporation rate. In order to characterise the salinity data the sigmoidal curve of salinity vs. depth was analysed through plots of the values of  $\log\{S_{\text{bottom}} / (S_{\text{depth}_x} - S_{\text{bottom}})\}$  which are used to determine the inflexion point in the salinity depth graph.

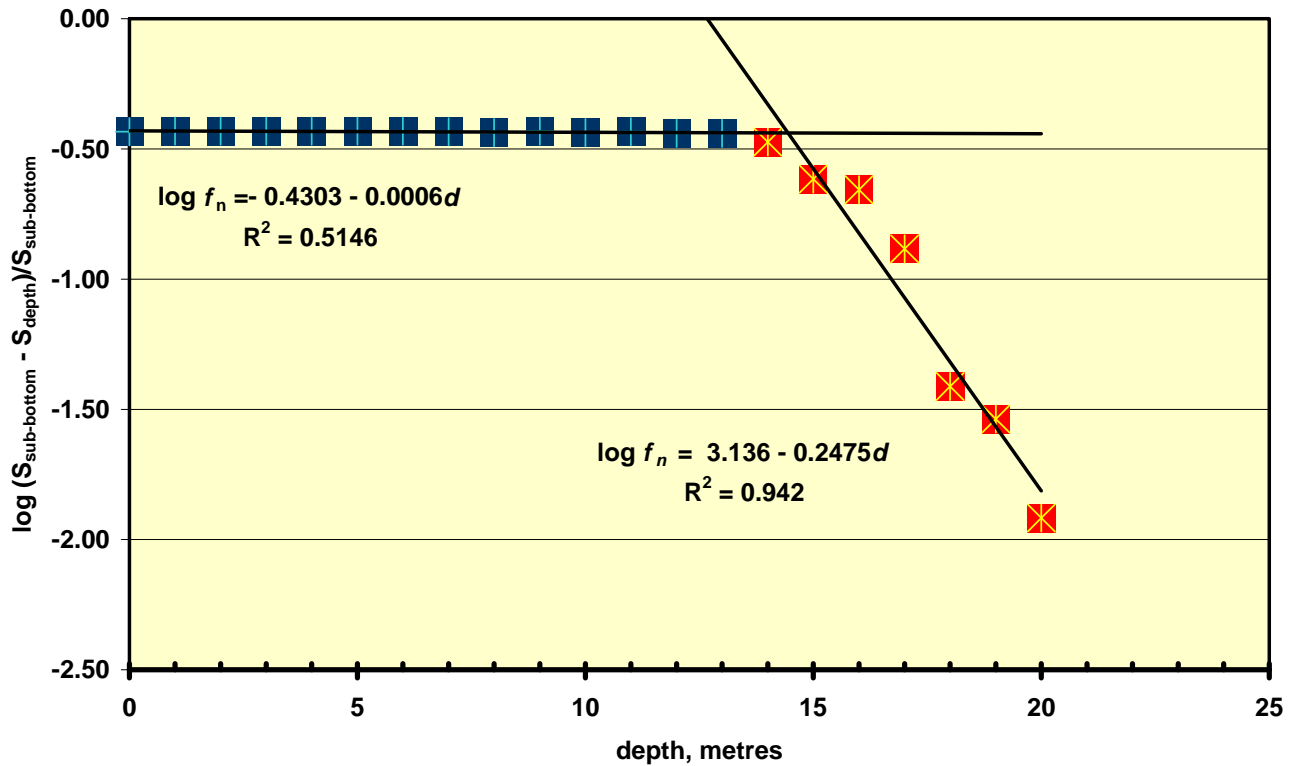
Figure 3: Plot of logarithmic difference function for salinity of the upper waters, Sea of Marmara

The turning point for the upper waters was found at a depth of 14.8 metres, as shown in Figure 3 by solving the simultaneous equations for the lower and upper parts of the sigmoidal curve. The reverse profile for salinity on the bottom of the AE2 site shows slightly lower values at depths of 68-73 metres and this is likely due to mud contamination on the bottom of the sensing probe after the initial excursion into the sediment. The data at the bottom of the site was also reproducible in terms of a slightly lower salinity in the sediment layers. In order to determine the reproducibility of the data a second set of readings were taken in the afternoon, but with the recordings limited to 5 metre intervals owing to limited operational time on the support vessel. Inspection of the data in Figure 2 shows that the salinity readings have a high degree of reproducibility. The mean salinity for the deeper waters on the AE2 site was  $41.3 \pm 0.8$  ‰ for depths between 20-74 metres and these values reflect the influx of more saline waters from the Aegean Sea which floods in from the Dardanelles. There was only one halocline observed over the whole range of depths on the site of the wreck. If the probe did penetrate part of the silt mound then this area has a mean salinity of  $39.3 \pm 0.12$  ppt which is statistically significant. The lower sediment salinity reflects limited exchange with the surface waters. Observations made through the ROV camera at the halocline noted the difference in light scattering over the depth range where the waters changed from lower to higher salinity. A similar optical presentation was recorded inside the submarine using the drop camera that had been inserted into the partly opened hatch inside the conning tower. Attempts to get the salinity probe inside the vessel were hampered by the increased distance from the submarine after winds had shifted the *Detek Savior*. It is possible that a halocline does exist inside the submarine. Once the sea cocks had been opened the vessel would have begun to fill with the lower salinity upper waters and once

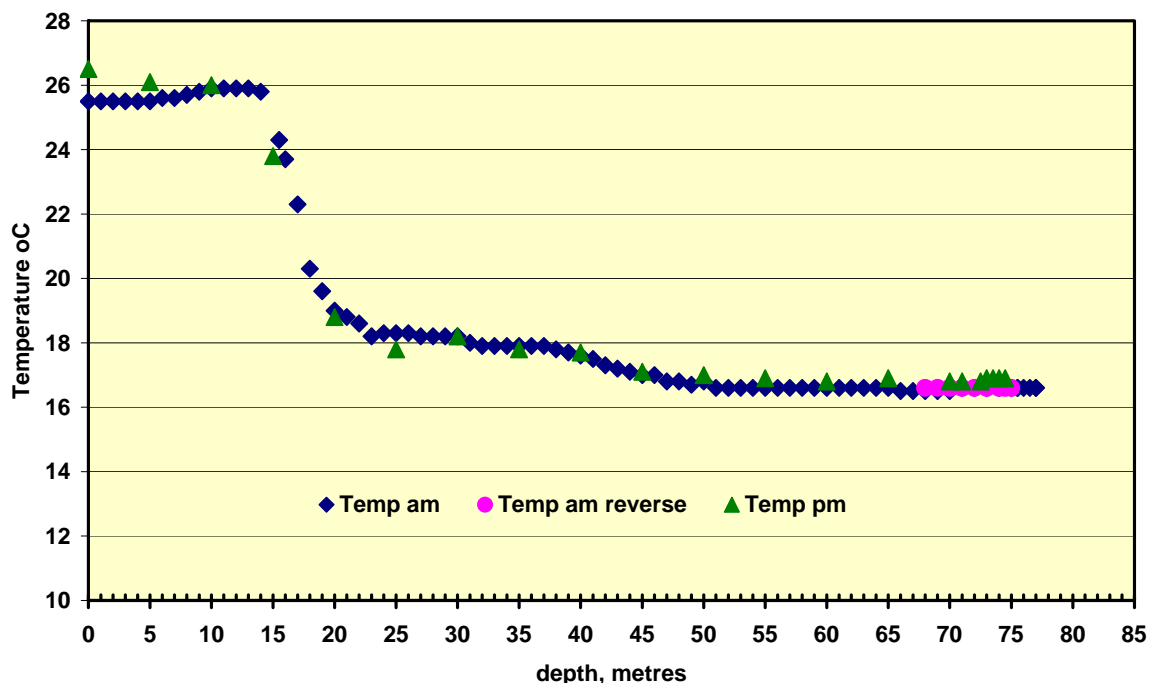
Figure 4 Temperature profile with depth on the AE2 site 14 September 2007

Through analysis of the simultaneous equations established by calculation of the ratios of temperature at known depth vs. sub-bottom temperatures plotted as a function of water depth it was possible to determine the turning point of the first halocline at 15.2 metres with top temperatures. The turning point of the salinity profile was 14.8 metres and given the uncertainties associated with ensuring that the cable was vertical in the water column, it can be stated that the temperature and salinity curves had the same turning point at 15 metres. It should be noted that there was no apparent hysteresis with the temperature profiles when the probe penetrated the marine sediments surrounding AE2. Given that the temperature probe is a modified thermocouple it is not surprising that the presence or absence of sediment on the tip of

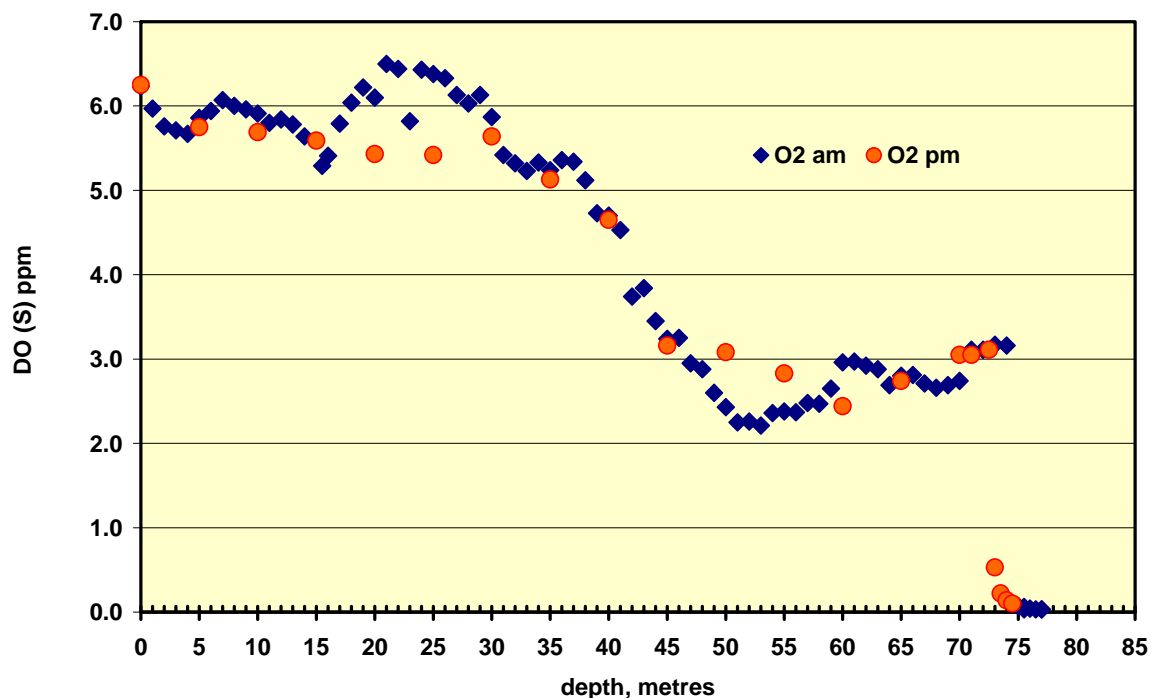
Figure 5: Plot of dissolved oxygen (salinity corrected) as a function of water depth, metres

Since determination of oxygen in seawater involves diffusion of molecular oxygen across a thin membrane, where it is consumed at an internal metal electrode, the values are not as reproducible as temperature and salinity, as the movement of the cable as the support vessel moves in response to wave chop causes localised eddies around the sensing head. The data obtained from the morning and afternoon measurements shows that the surface water is well oxygenated at between 7 and 5.5 parts per million and that the values fall from 5 to 3 ppm as

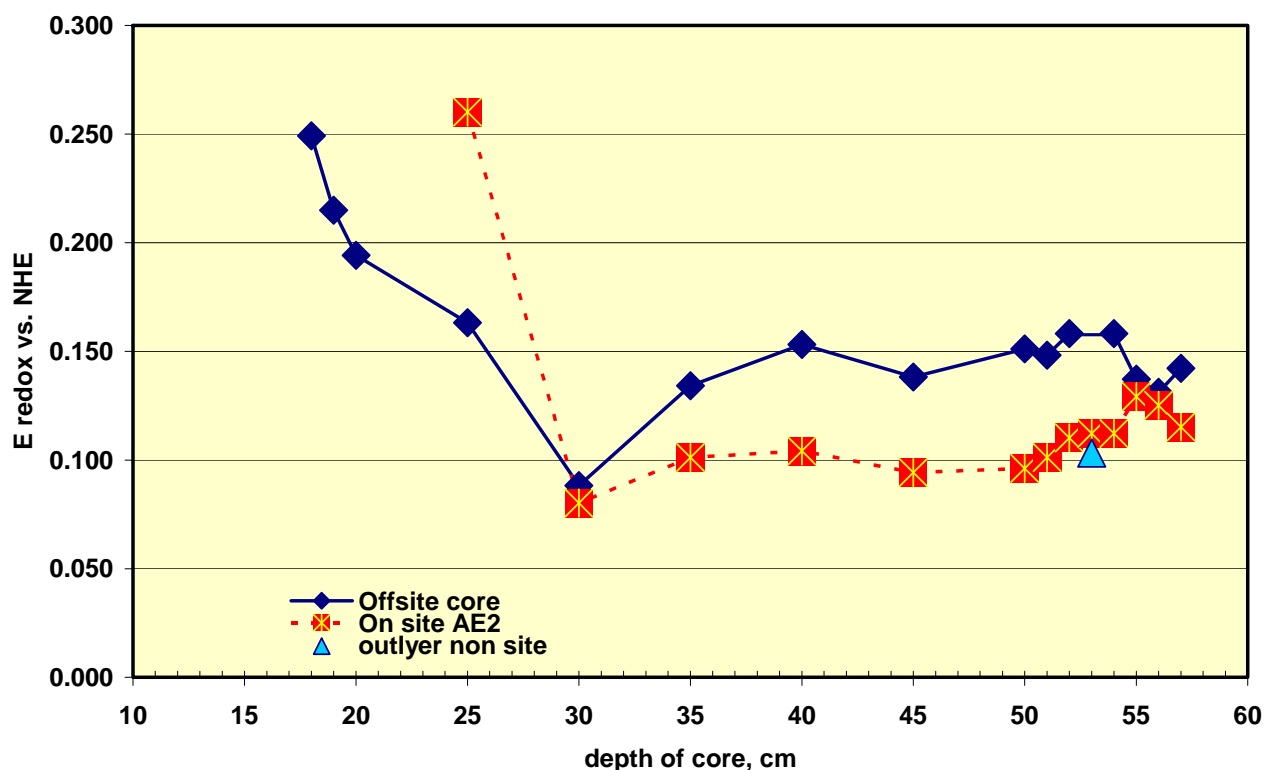
The mean redox potential of the sediment core adjacent to AE2 was  $+0.119 \pm 0.044$  volts vs. NHE while the mean value for the core obtained 20 metres from the site was  $+0.157 \pm 0.038$  volts – see Figure 8 for a plot of the redox potential vs. depth of the sediment core. These data sets include all the values of the redox potential, measured at a rhodium electrode (0.5mm wire, 2 cm long sealed into a Vycor<sup>®</sup> seal into a Pyrex glass and silver soldered to a 0.5 mm hard pitched copper wire) in conjunction with a Ag/AgCl double junction reference electrode which had been calibrated against a platinum electrode in a pH 4.0 buffered solution of saturated quinhydrone (a 1:4 adduct of quinone and hydroquinone) and had a voltage of +0.228 volt vs. NHE.

Figure 8: Redox potential of the sediment cores as a function of distance from surface

When the more oxidising values in the upper layers of the sediment core are excluded, the differences between the two cores became more apparent, as seen in Figure 8. The more oxidising values represent the changing amount of dissolved oxygen in the interstitial waters and in the upper layers of the sediment core. The AE2 core in the deoxygenated zone had a mean redox potential of  $+0.107 \pm 0.014$  volts, whilst the corresponding section of the core obtained away from the influence of the submarine had a value of  $+0.142 \pm 0.020$ . The difference between the mean values of the cores is 35 mV and the sum of the standard deviations is 34 mV, which indicates that the differences are just statistically significant, to a 92.5% confidence level. If the outlier value in the off-site sediment core is included the mean value increases to  $+0.154 \pm 0.039$  volts.

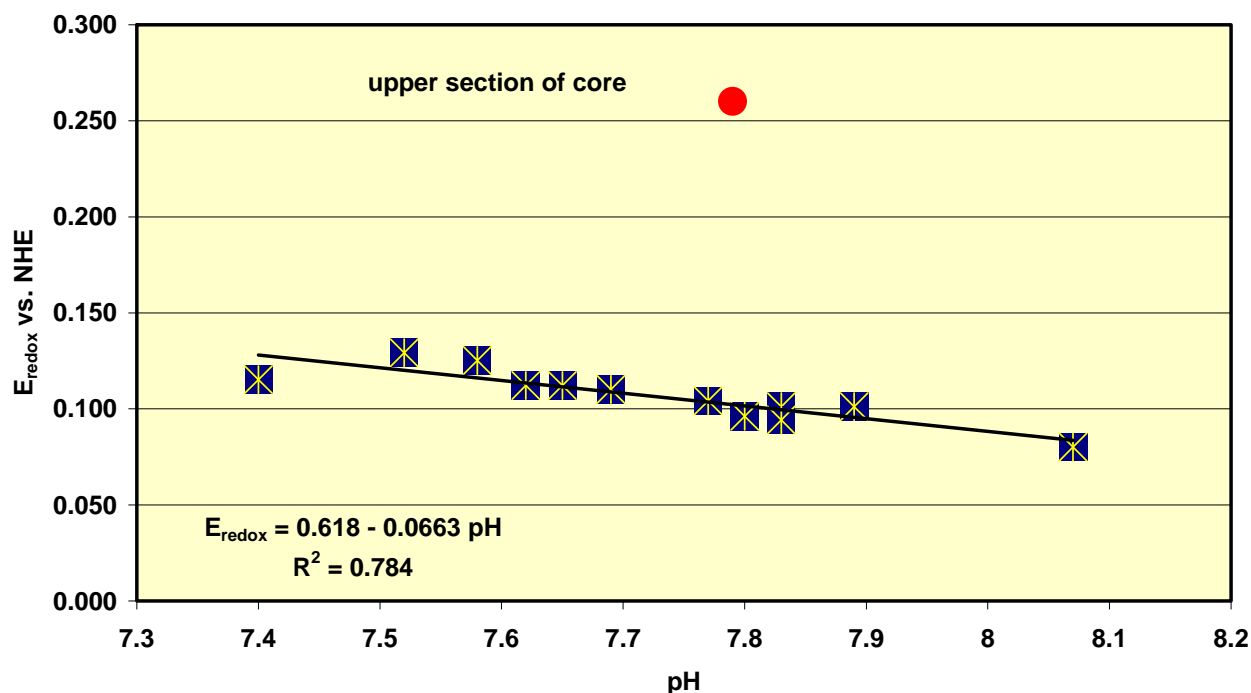
When the off site core  $E_{\text{corr}}$  was plotted as a function of the pH it was found that there was no systematic relationship between the two variables which is consistent with there being no dominant chemical solution processes taking place within the sediment. Changes in activity of the microbiological populations can lead to production of acidic metabolites which then exert a major influence on the local pH. The data from the sediment core obtained adjacent to the AE2 site had very different properties to the redox data collected closer to the support vessel. Although the correlation coefficient is not high, the slope of  $-66 \pm 11$  mV per unit change in pH is consistent with the voltage being controlled by the reduction of the interstitial water in an essentially anaerobic microenvironment which consumes one hydrogen ion per electron and has a slope of  $-0.059$  millivolts – see Figure 9.

Figure 9: Plot of the redox potential  $E_h$  for the AE2 site core as a function of sediment pH

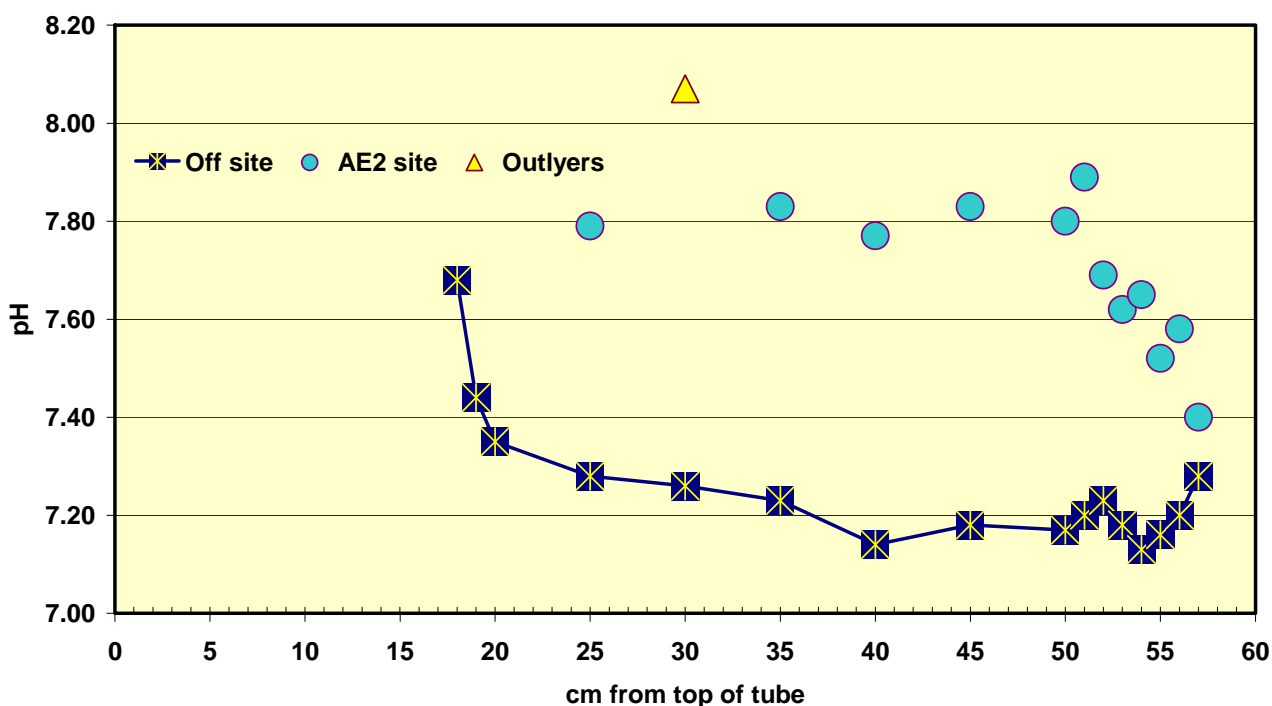
When the pH data from both the on-site and off-site core are plotted as a function of the sediment depth the differences between the two cores is quite apparent and is seen in Figure 10. The pH values of the core close by the submarine shows a steady alkaline microenvironment of approximately pH 7.8 before moving to less alkaline values over the last 7 cm of the core at a rate of -0.05 pH per centimetre distance down the core. The off-site core had a similar starting point to the AE2 core but the pH rapidly fell in the first 10 cm to  $7.1 \pm 0.1$  until both cores obtained similar pH values at the bottom of the profiles. Without access to data on the microbiological populations in the cores it is difficult to determine the underlying causes that give rise to the observed patterns of acidity across the sediment cores.

Figure 10: Plot of pH values of the AE2 site and off site cores as a function of sediment depth.

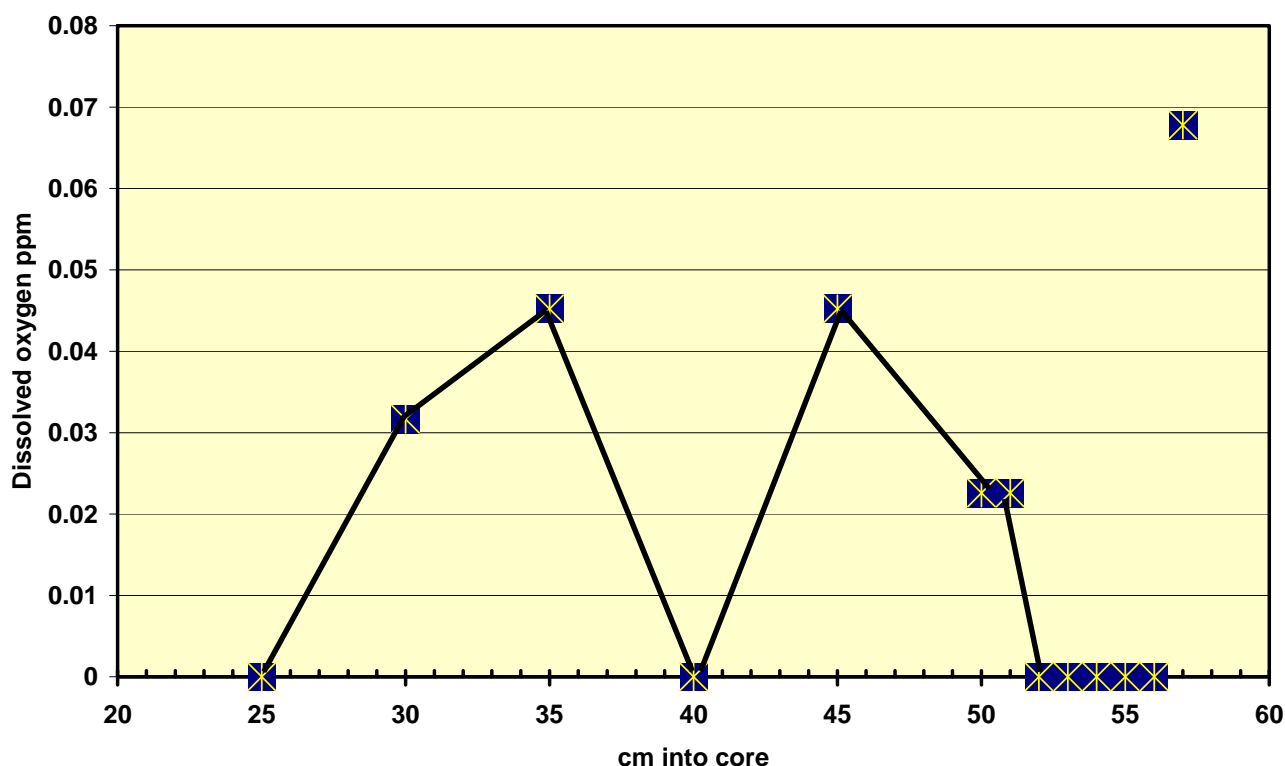
Measurement of the dissolved oxygen in the cores involves careful insertion of the microelectrode into the silty sediment layer through the pre-drilled hole and waiting for the reading to equilibrate. The basic characteristic of the two cores is that they are essentially anaerobic after the first few centimetres of sediment, which is not surprising since the seabed is composed of a very dense grey clay-like mineral deposit. The off-site core had increasing dissolved oxygen content from zero to 0.2 ppm in the last 7 cm of core which may be a reflection of reduced microbiological activity in this zone or it could be due to systematic errors introduced in the sampling and measuring processes. It is likely that the very low levels of dissolved oxygen in the AE2 core, as seen in Figure 11, are the result of experimental and operator error since the majority of the readings within the core reflect zero dissolved oxygen concentration.

Figure 11: Plot of dissolved oxygen concentrations in the core from the AE2 site

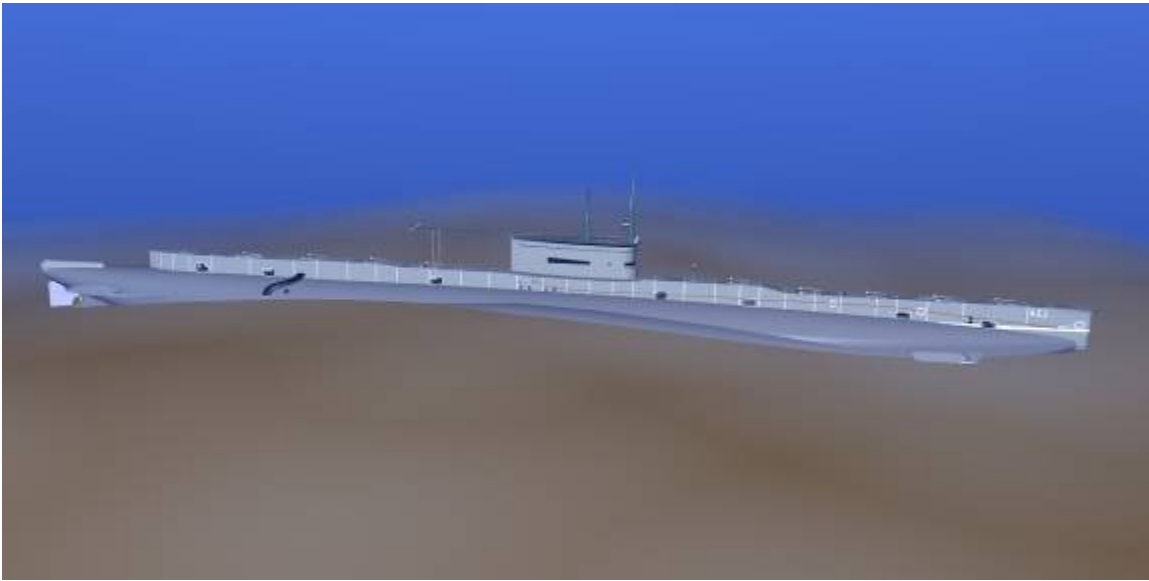
The exposed parts of the vessel were visually inspected in their entirety by the ROV. As has been previously reported, the submarine appears to be sitting virtually level, but perhaps slightly bow-down. The sediment in the vicinity of the midships is built up to within a metre of the top of the saddle tanks, and there is less sedimentation towards bow and stern. The forward hydroplanes are just clear of the seafloor, as is the forward torpedo tube door. There is a fair amount of scour around the aft end of the vessel, with the consequence that the rudder and at least one propeller blade are visible. Figure Three is a representation of the level of the build-up of seabed material along the length of the submarine (starboard side, AE2 presented in its nominal 1915 condition).

Figure 3. A representation of AE2 as she is lying on the seabed.

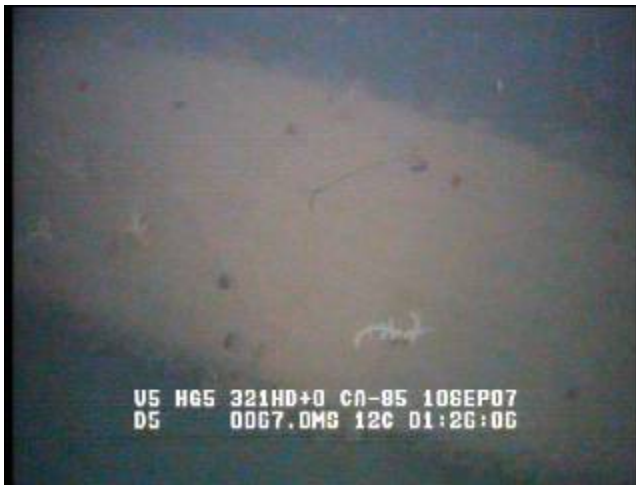
The following image shows a section of intact casing, which includes very cleanly preserved vent holes.

Figure 12. An intact portion of casing.

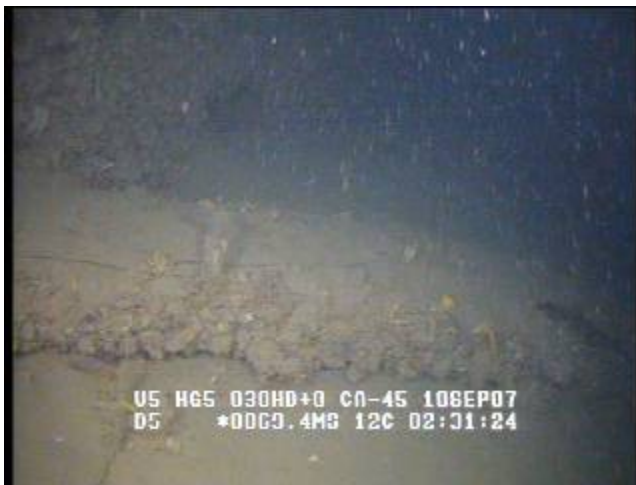
Both exhaust outlet pipes are in place and substantially intact. The portside pipe has a large hole, which is probably simply attributable to corrosion. This is to be expected, considering its previous employment carrying hot gasses internally while having its outside surface intermittently quenched by cold water.

Figure 13. Portside exhaust pipe.

Figure 13 illustrates the portside exhaust. Also visible in the background of the figure is an opening in the casing. This is not damage – it is, in fact, an access hole for a cleat.

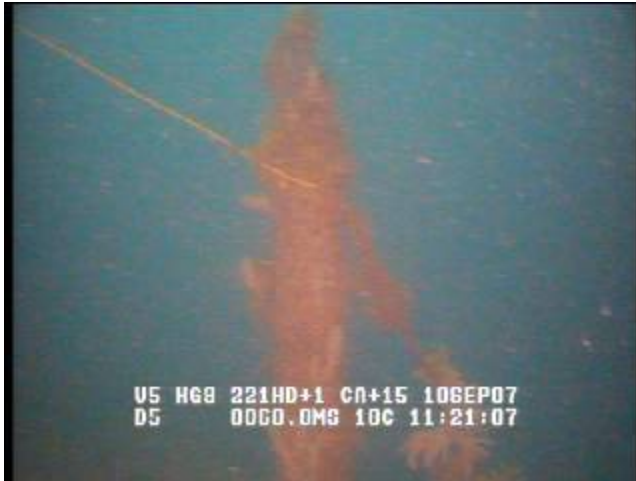
The telegraphy post is still in place and, despite being festooned with fishing equipment, appears to be structurally intact.

Figure 14. Telegraphy post.

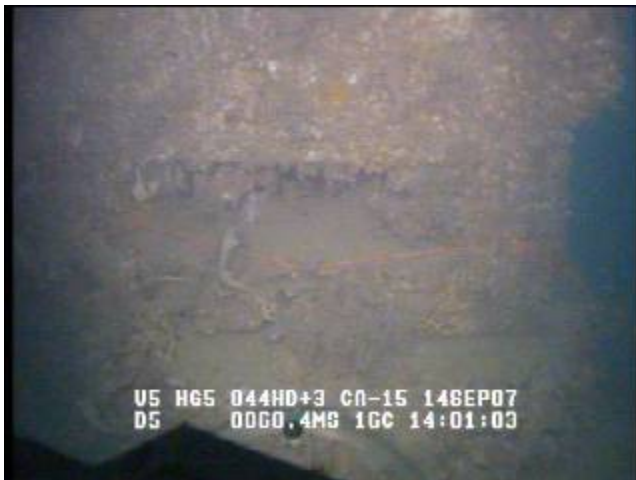
The forward end of the fin, which was constructed out of non-ferrous materials including naval brass and gunmetal, is complete. It still has its navigation lights in place, as are all of the viewing ports. The periscope standards are still in place and the jumping wire between these is intact. The periscopes themselves have been sheered off at some stage.

Figure 15. Starboard forward viewport on conning tower.

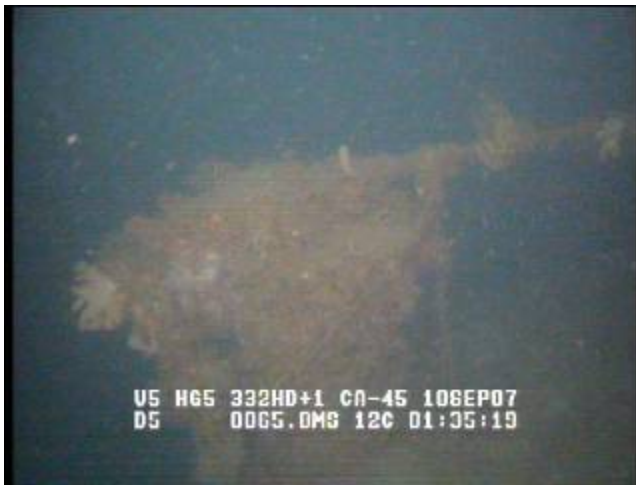
Figure 16. Forward periscope standard and jumping wire.

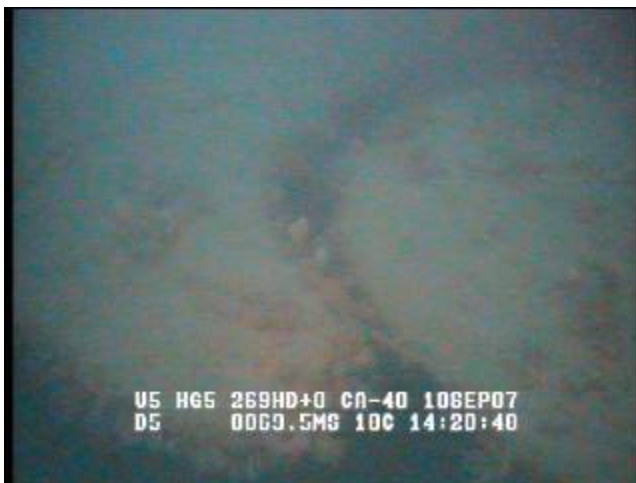
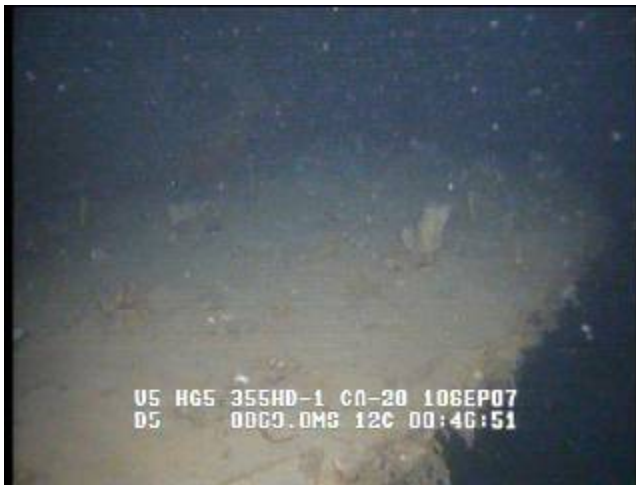
The aft hydroplanes are set horizontal. These are well clear of the seabed, so it was possible to undertake detailed inspection of both surfaces. Both port and starboard units appear to be in good condition, as evidenced by the following images.

Figure 19. Portside aft hydroplane.

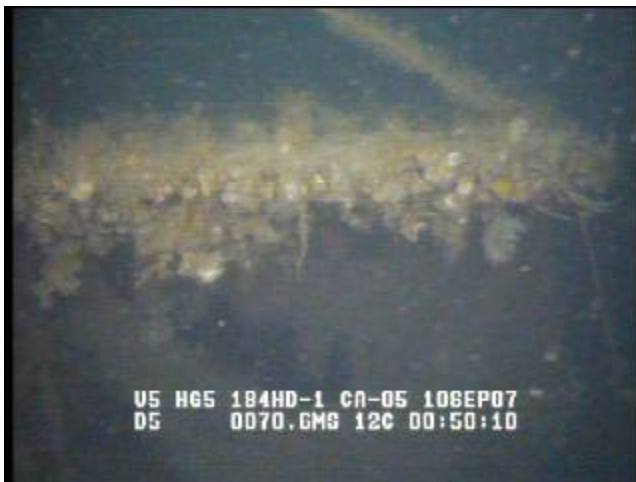
Figure 20. Starboard aft hydroplane, with fishing nets hanging below it and lines above.

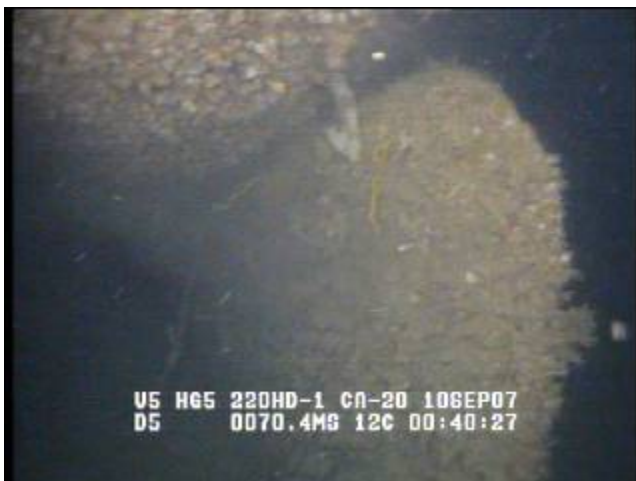
The rudder is substantially clear of the seabed. It is heavily encrusted, but appears to be complete. It is canted to starboard, perhaps at fifteen degrees, indicating that the vessel was still actively manoeuvring until the decision was made to abandon ship.

Figure 21. The rudder

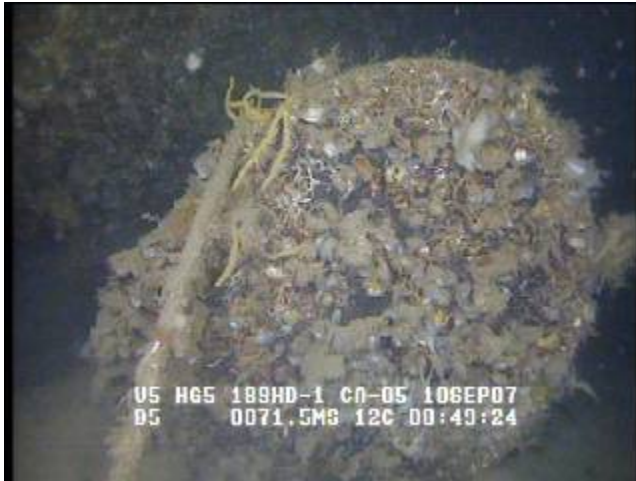
A single blade of the starboard propeller is clear of the seabed. One of the aims of the Battle Damage Survey was to inspect the propellers for damage that may have been caused when the submarine grounded in the Dardanelles Strait. The single blade that is visible appears to be in excellent condition, with no signs of damage.

Figure 22. Starboard propeller blade

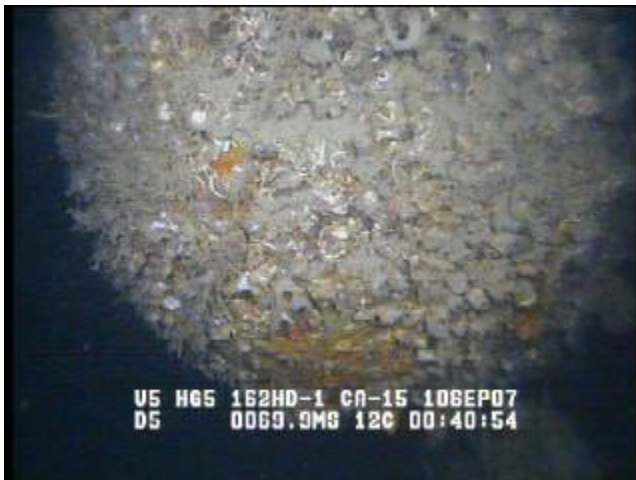
The aft torpedo door is very heavily encrusted with marine growth, so it is not possible to make judgements on its condition. The cover for the opening mechanism was relatively lightweight construction, so has suffered quite significant corrosion damage. As has been the observation elsewhere on the vessel, however, the underlying machinery appears to be in a good state of preservation.

Figure 23. The aft torpedo door.

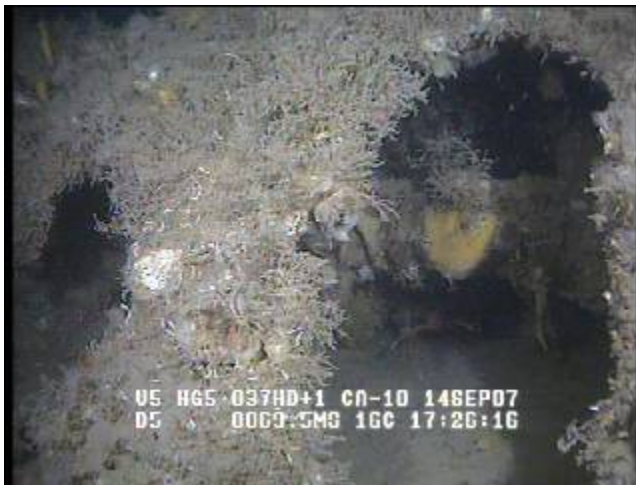
Figure 24. Torpedo door opening shaft.

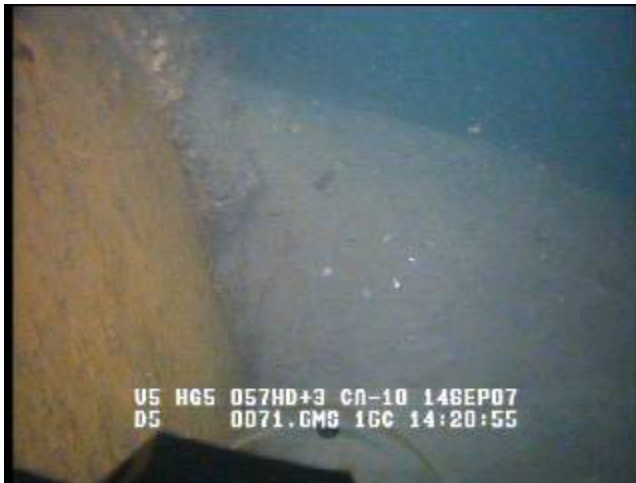
There is a build-up of sediment amidships on both sides of the vessel, but slightly higher on the port side. This probably amounts to a peak height of 1-2 metres and the build-up begins about 4 metres from the side of the submarine. Because the ROV pilot maintained a

Figure 25. This shows the sediment profile in the vicinity of frame 41. The profile was exposed unintentionally during a storm event, resulting from sediment removal by a concrete block that was dragged across the seabed and impacted the portside saddle tank.

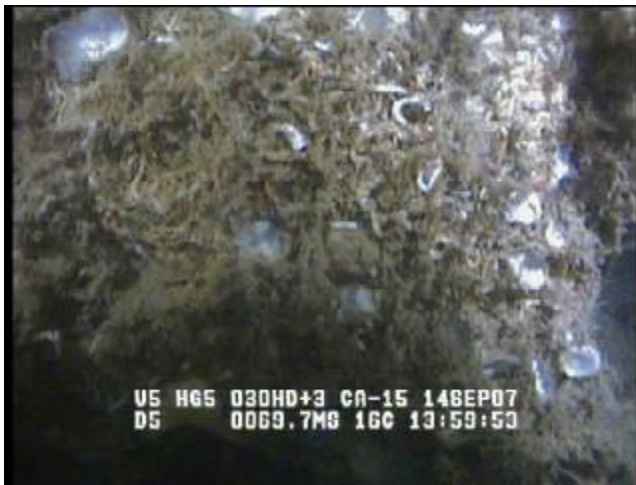
At the measurement site on the casing, only one reading was recorded as being stable. This was 8.55 mm. Figure 27 shows the final approach of the ROV prior to taking the measurement. The site at which the reading was taken is approximately 60 mm from the break in the casing, which means that the position of the location site almost certainly overlay a casing frame. Hence the recorded thickness may be of combined casing material and frame. The original specified thickness of the 5 lb plating was 3.1 mm and the underlying angle-section frames had wall thickness of 4.8 mm. Hence the combined, specified thickness was 7.9 mm. This represents a difference between measured and specified thickness of 8%, which would be quite acceptable if the metals were new. The reality, of course, is that there is considerable corrosion evident in the casing. The MacLeod (2007) report discusses the nature of the corrosion processes in low-oxygen environments. Specifically, it appears that the corrosion process may not have produced the usual, relatively defined interface between the base metal and the overlying primary corrosion layer and as a result the ultrasonic system may have failed to measure the thickness of the underlying base steel. This could result in a thickness measurement that is rather high. It will be seen below that the measurements taken on the cleaned site also appear to be high. A method, described below, has been proposed to cross-check and validates these measurements and perhaps to develop a model that may allow some conclusions to be drawn of the actual nature of the residual material of the submarine.

Figure 27. The final approach by the ROV prior to taking thickness measurement. The Break in the casing can be seen at right of view.

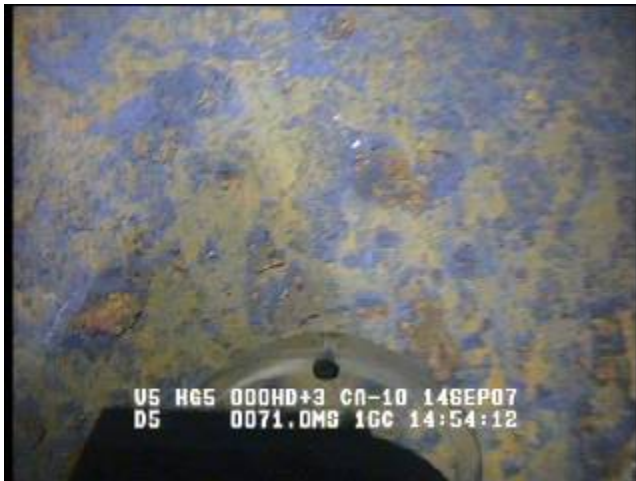
Figure 28. Preparing to take a thickness measurement in a 'cleaned' area. Note the row of rivets overlying a rib is flush and well seated. To the left of the field of view is a joint between plates, which had an underlying butt strap.

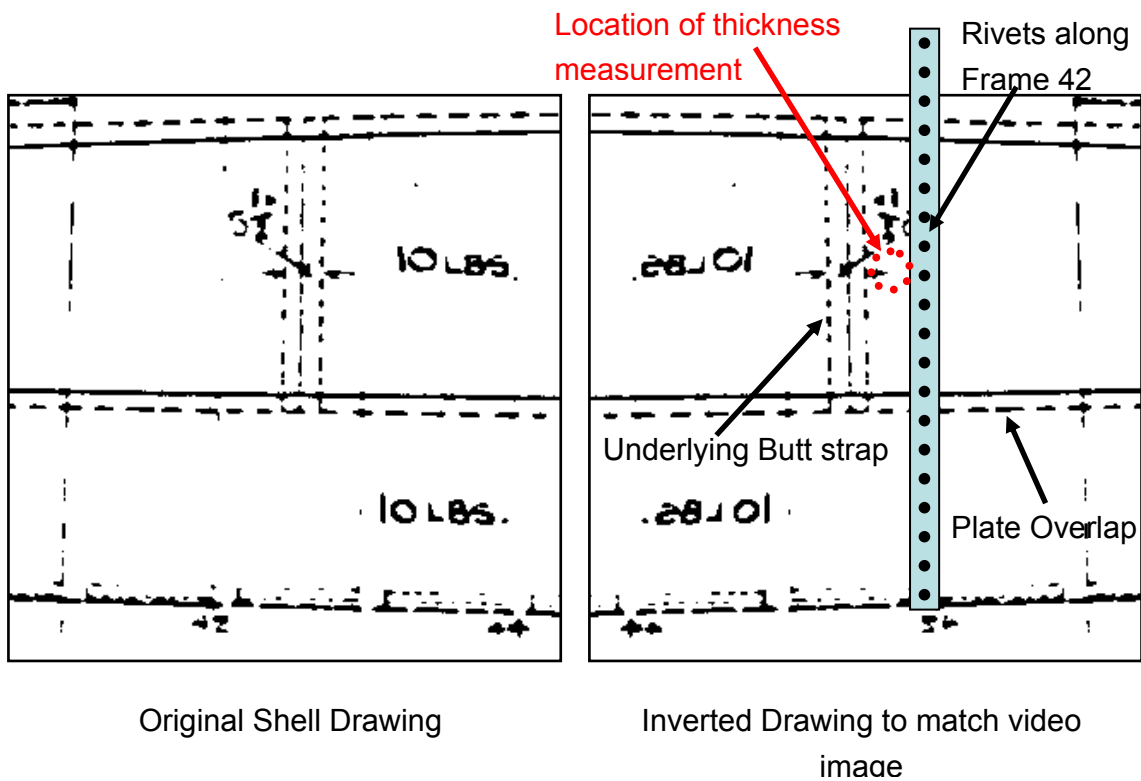
Figure 29. Showing the corresponding site for the measurement taken in Figure 29.

Finally a series of measurements were taken at the site where the concrete block had cleared the concretion off the surface of the saddle tank. It was not possible to exactly map the location of each measurement, and it will be seen in Figures 28 and 29 that this is an environment which was rich in plate overlaps, frames, butt straps etc. Consequently several of the measurements *could* have been taken over the top of double thickness plates, or even double thickness plates with underlying angle frames. After sorting into thickness order, a grouping appears to form as follows:

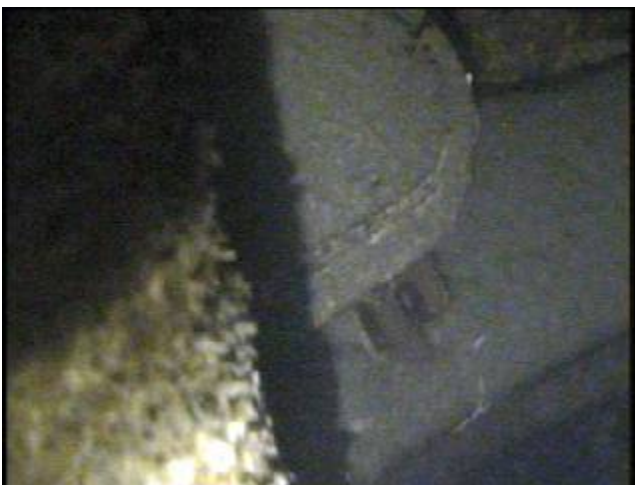
Figure 35. The aft, portside scuttle is open – a last look before abandoning ship?

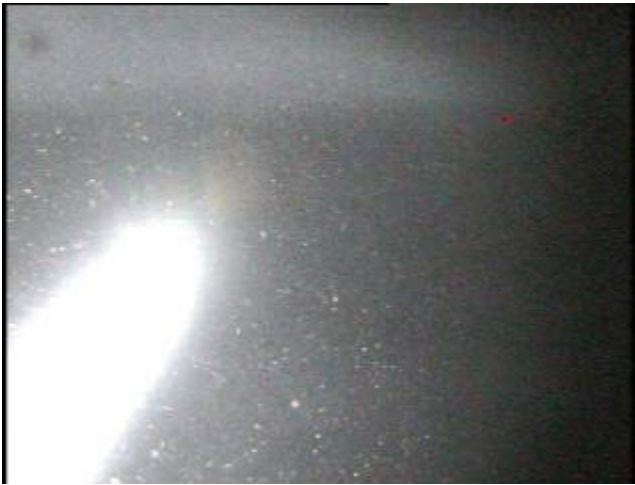
Another unexpected finding was that the submarine appears to have its own internal halocline. This had a clearly defined profile and had a distinctive; 'foggy' layer approximately one metre below the top of the hull. As a result of this finding the team developed a plan to insert a dissolved oxygen sensor into the hull, but unfortunately poor weather prevented this being done. An important objective of any subsequent expedition should be to further investigate this phenomenon.

Figure 41. The lower surface of the internal 'halocline' is clearly visible in this image.

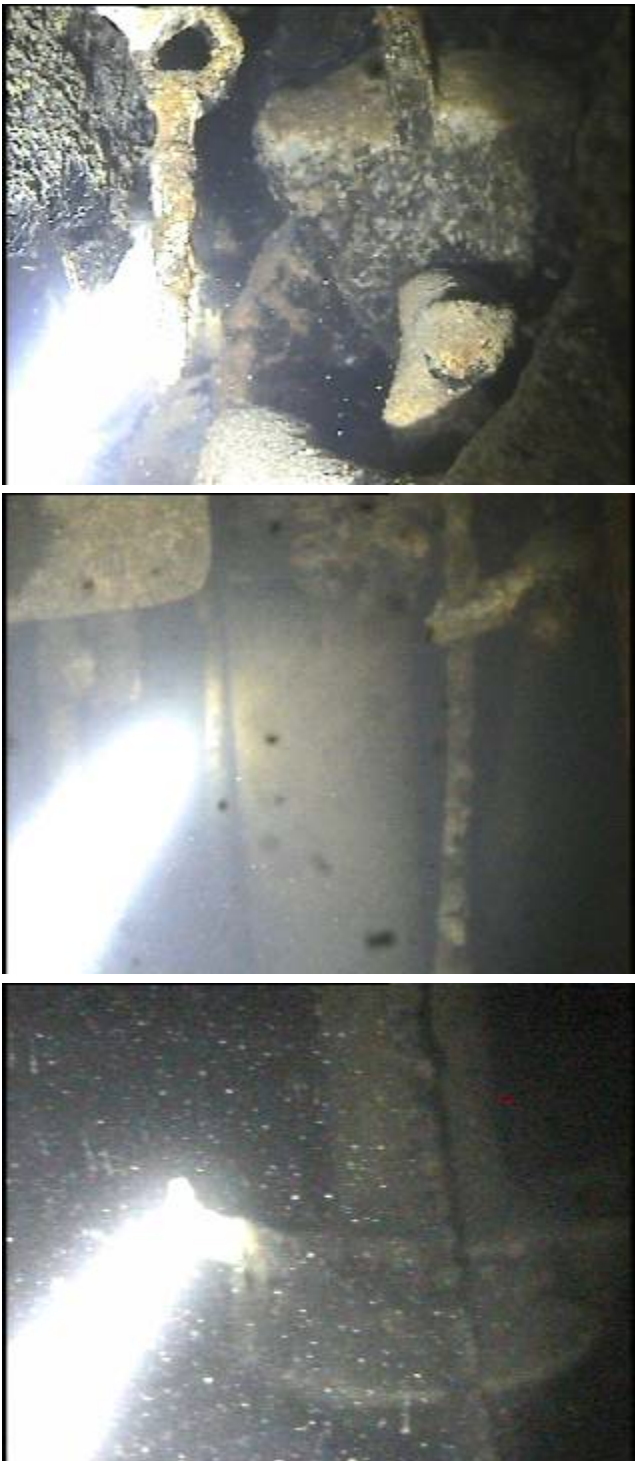
High up in the control room the periscope shaft is very clean, and also visible is the limit switch (an automatic cut-off that prevented the periscope being raised too high) and the training gear-train also appears to be visible, although this seems to be heavily corroded.

Figure 42. The aft periscope, showing (top to bottom) views above the support mount, the periscope shaft and the training ring immediately above the eyepiece and training hand/es.

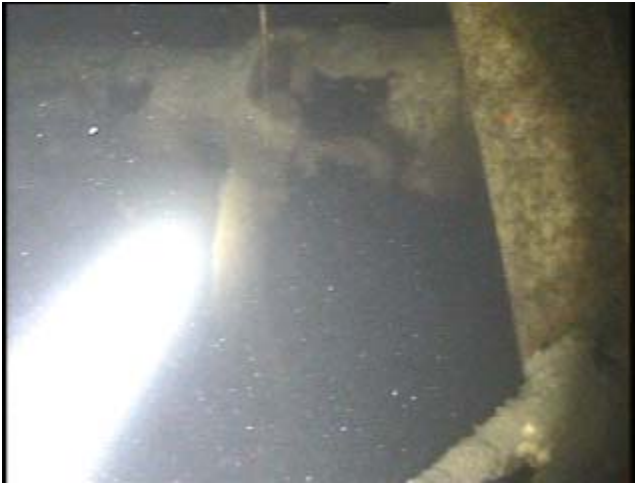
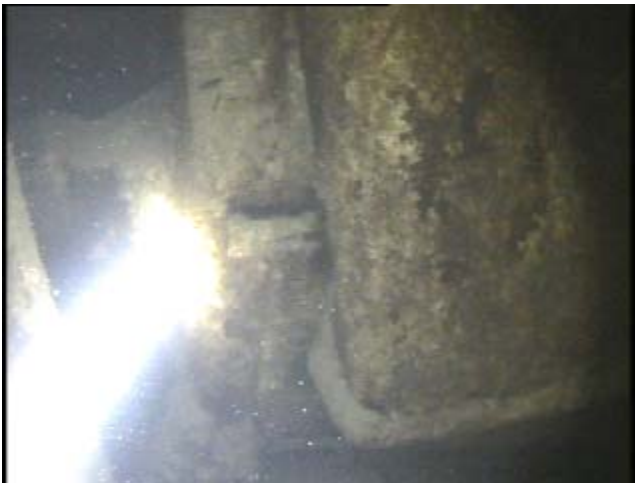
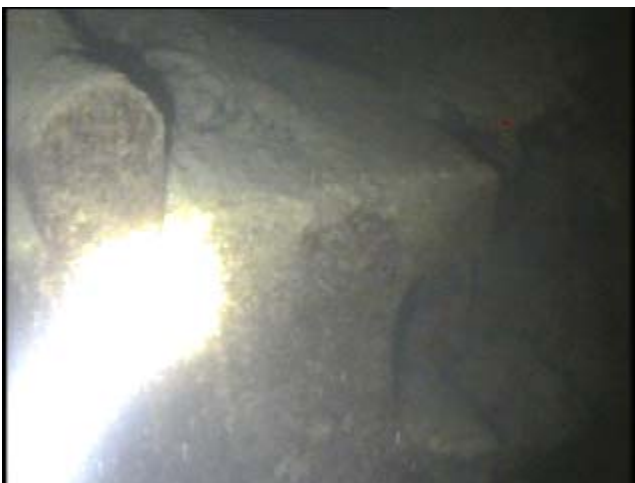
The steering engine sits slightly forward of the main hatch opening, and to the port side. It was an electro-mechanical unit which drove a shaft, via a series of universal joints, leading to the tiller flat at the stern of the vessel. There was also a shaft leading through to the upper steering positions in the conning tower, as shown in Figures 39 & 40. The original paint finish of the machinery was white (painted in the 'best oil paint' comprising white lead paint (Vickers Sons and Maxim, 1914). A good indication of the condition of the interior is that there is still white paint visible on the steering engine.

Figure 43. Showing details of the steering engine (a) main shaft (b) main electromechanical unit and (c) mounting and gearbox leading to conning tower. Note the small amount of sediment sitting on the flat surface of this unit.

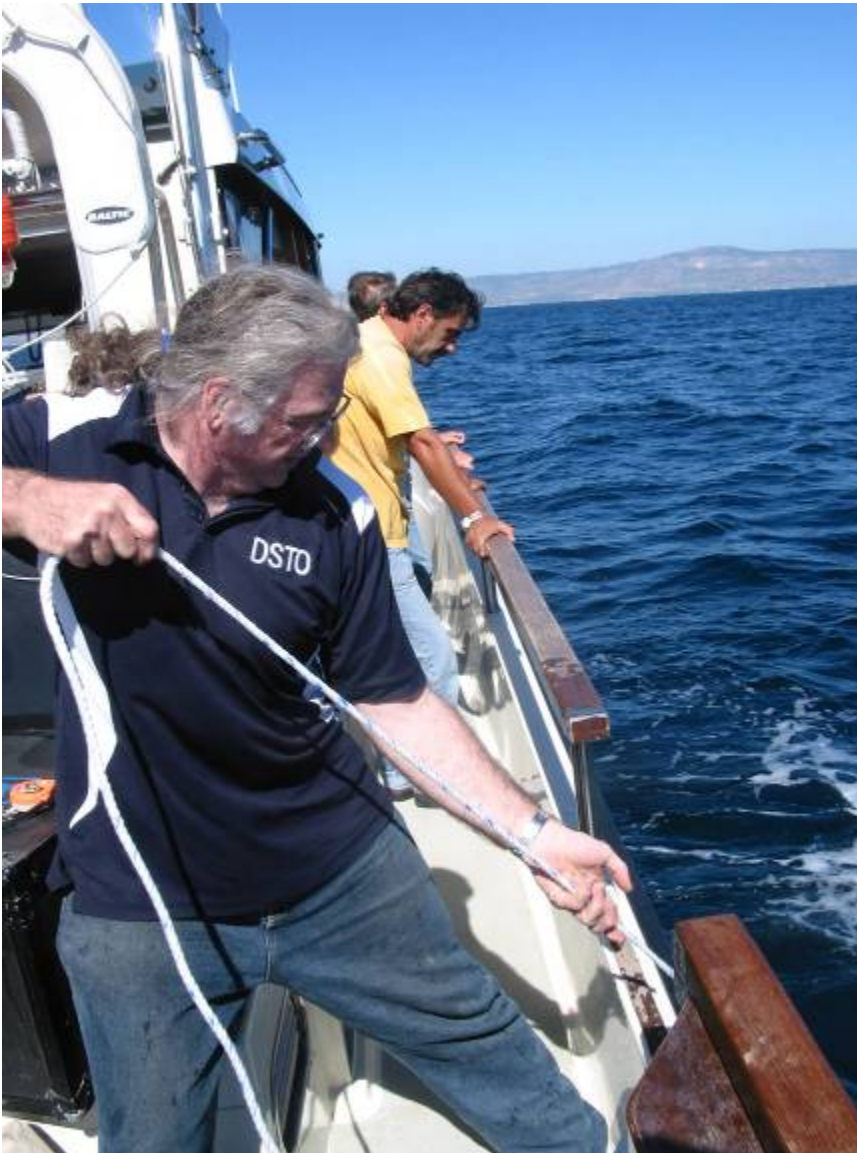
Figure 46. Rapid recovery and re-release maximises the number of impacts that can be recorded. Dr Roger Neill DSTO Task Overseer doubles as ROV handler.
