**REPORT OF OPERATION SILENT ANZAC  
MARITIME ARCHAEOLOGICAL ASSESSMENT OF HMAS  
AE2**

Name	Position
<b>Prepared By:</b>	Tim Smith	Maritime Archaeologist
<b>Approved By:</b>	Terence Roach	Director of Operations
<b>Authorised By:</b>	Peter Briggs	Chairman AE2CF

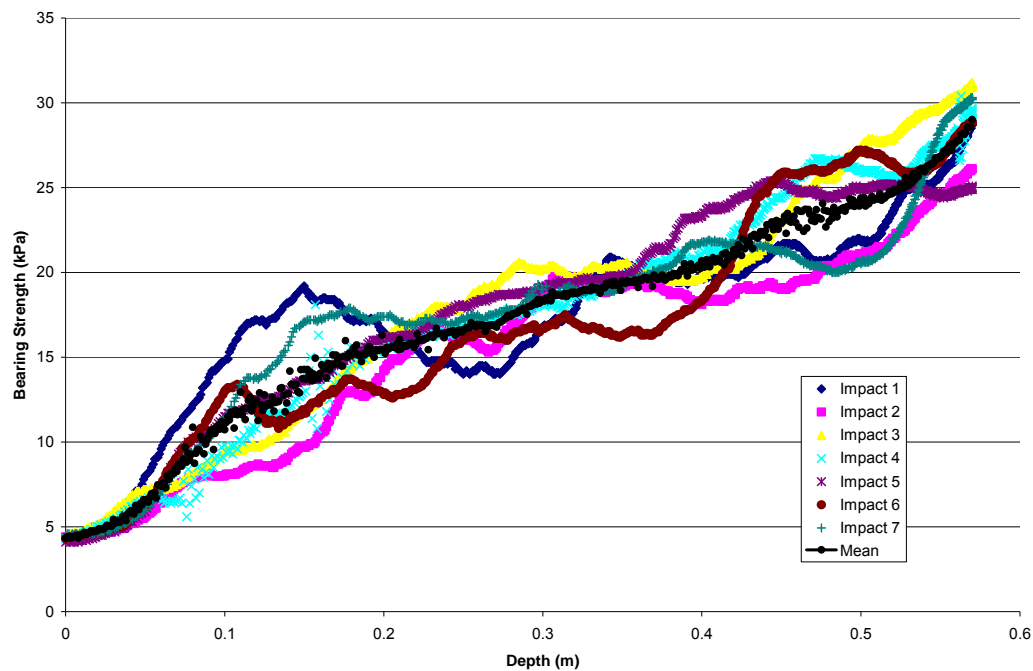
The recordings were undertaken on 18<sup>th</sup> September, 2007. In the event, seven impacts were recorded and the bearing strength data derived from these are shown in Figure 47. The position at which the readings were taken was 50 metres North East of the centre of AE2.

Figure 47. Bearing strength versus depth below the seafloor, 70 mm probe used.

The relationship between bearing strength and depth appears to be quite linear. A linear regression was performed on the mean impact data. This resulted in a slope of 36.5 kPa/m, intercept value of 6.7 kPa and a correlation coefficient ( $R^2$ ) of 0.96, which is highly significant. With the 70 mm tip maximum penetration was just under 0.6 metres. To confirm the linear trend, the tip was replaced with a nominal 25 mm probe end and the test repeated. This yielded a maximum penetration of 1 metre, and the graph was linear throughout its full range. The bearing strength values derived from this trial are not included because Mulhearn (2002) has warned the 25 mm tip produces measures requiring correction in absolute terms, but he confirms that the trends revealed with the 25 mm tip geometry are very representative. Hence it can be concluded that the seabed is quite uniform up to a depth of at least 1 metre.

The above linear regression equation was used to extrapolate the predicted bearing strength data to a depth of three metres, using 0.1 metre increments. These data were then used to predict the depth of burial for AE2. The consulting naval architect and marine engineer, Mr Michael Rickard-Bell undertook a draught calculation using repeated iterations of increments of 27 waterplane area sections. His predicted depth of burial is 2.7 metres, as shown in Figure 48. The silt-line representation shown in Figure 3 was prepared prior to this analysis being undertaken, but a comparison of the two figures shows there is excellent consistency between the observed level of burial and the prediction. This gives a good level of confidence that, if proposals are raised requiring interference with the underlying seabed, valid assessments can be made of the likely impact such interference will have on the ability of the remaining material to continue supporting AE2 in her present attitude.

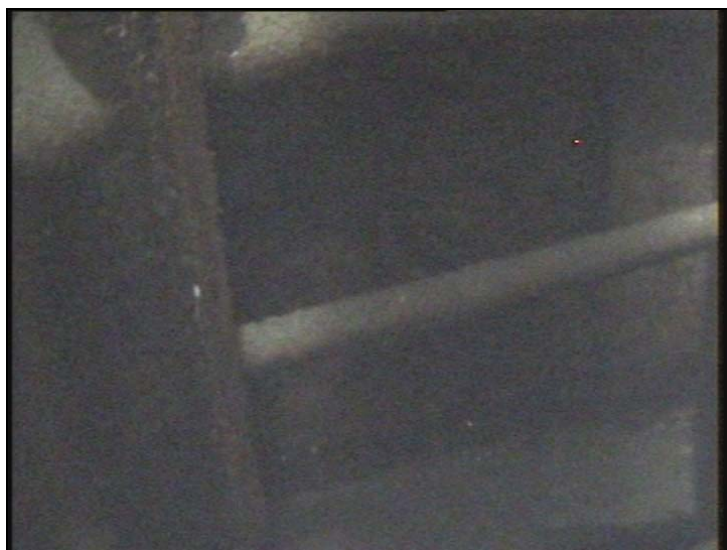
Figure 1. Interior access ladder within conning tower. Seen for the first time in 92 years.

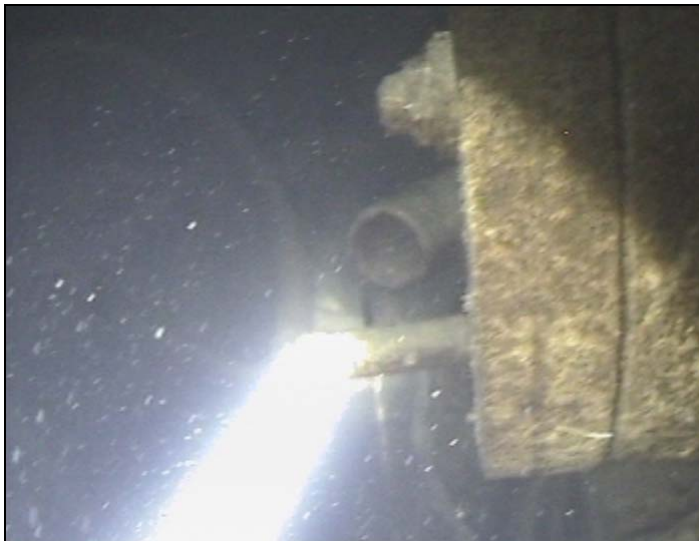
Figure 2. An engine telegraph repeater, auxiliary steering wheel and possible voice pipe in upper conning tower.

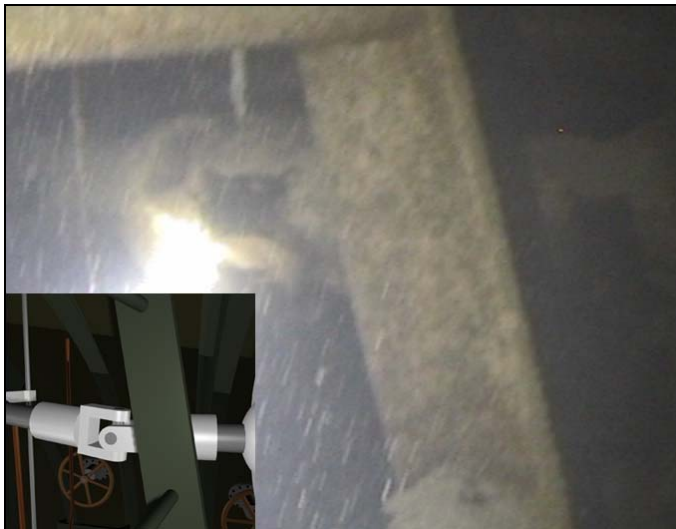
Figure 3. Through the lower hatch and into the control room. Camera captures universal joint in steering rod, as generated in a computer generated view of the control room space.

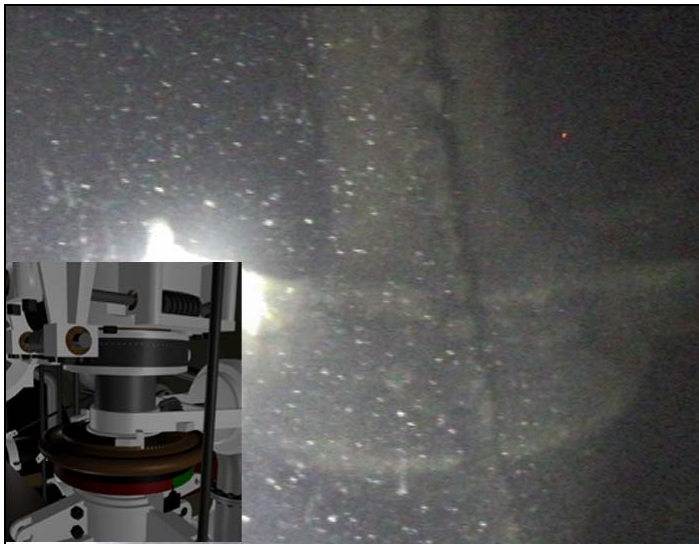
Figure 4. The aft periscope appears from the dark.

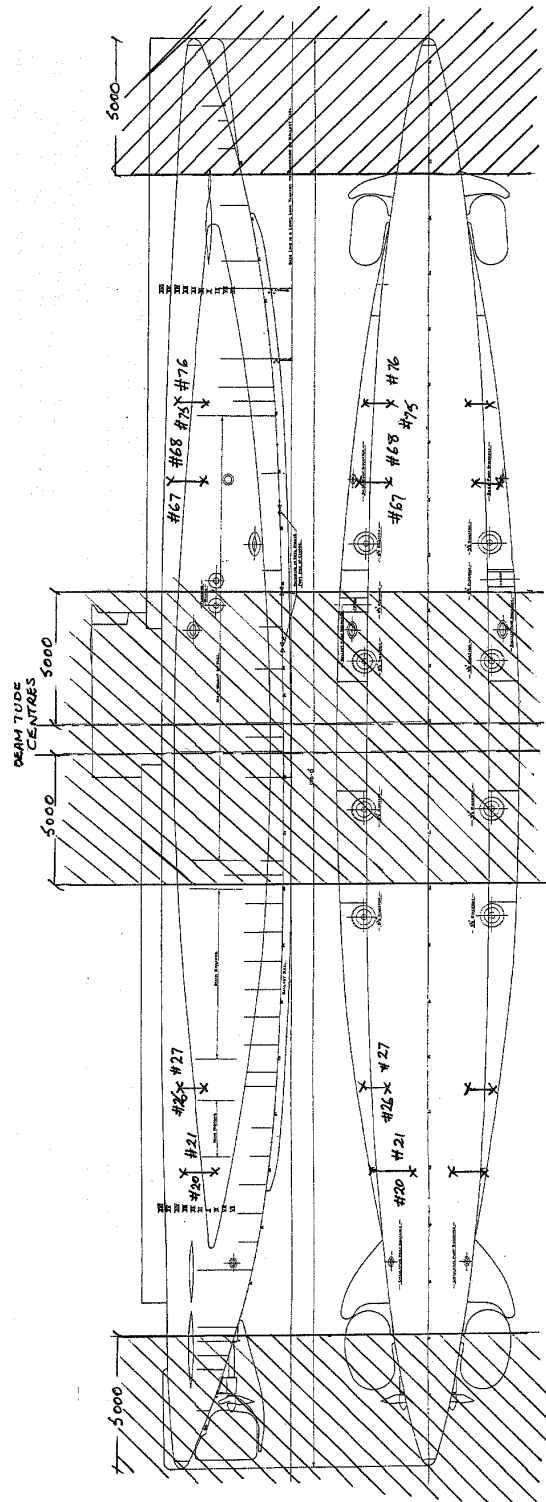
Figure 1 Measurement Points

The contribution to hull girder strength from both the ballast tanks and the superstructure were ignored in this analysis. It did however identify areas of localised maximum stresses and/or structural discontinuity; from which 16 sites were identified for the subsequent measurement of the thickness of pressure hull and ballast tank plating as part of the MAA. The location of these measurement sites was subsequently revised after it had been established that the warhead of an unexpended torpedo on board could be in a highly explosive state. The final locations were as depicted in Figure 1 at Appendix 1. The actual reading locations differ from these (see below).

A Cygnus Multiple Echo Ultrasonic Digital Thickness Gauge was chosen for the measurement of plating thickness. The thickness gauge functions by identifying the successive reflections from the near and remote surfaces of the base metal layer, and calculating the thickness from the average transmission time of the acoustic signals through the metal. The unit was tested during the training exercise conducted prior to the MAA. Two of the divers nominated for the MAA became quite proficient in the use of the hand held instrument that required the orientation of the transducer be rotated until a steady reading was registered. The divers were also advised of the thickness readings likely to be registered at each of the nominated sites. Sites on both the pressure hull and the ballast tanks were specified as shown in Figure 1 at Appendix 1

- Notes: 1. Thickness measurements were unable to be made at these locations.  
2. Cross hatched areas indicate explosive risk areas which were avoided.

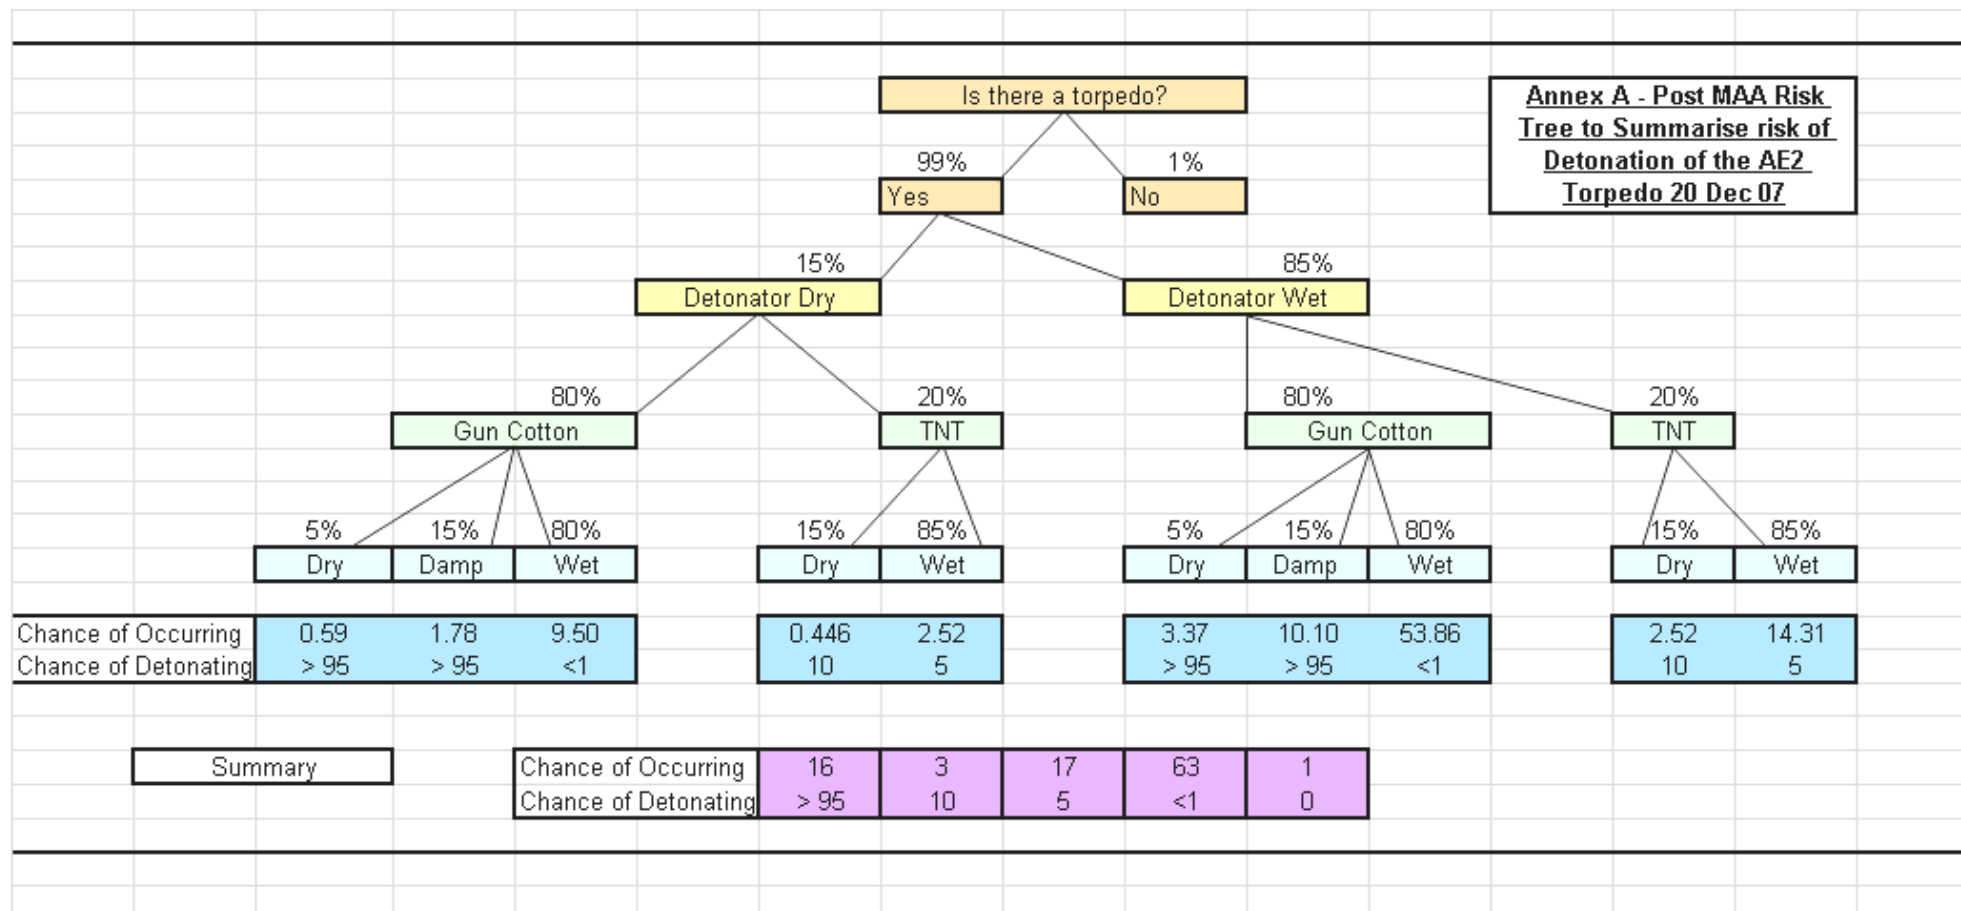
Figure 1 Post MAA Risk Tree to summarise risk of detonation of the AE2 torpedo
